# WATER QUALITY MEMORANDUM

## Utah Coal Regulatory Program

RE: 2012 First Quarter Water Monitoring, PacifiCorp, Deer Creek Mine. C/015/0018,  
Task ID #4020

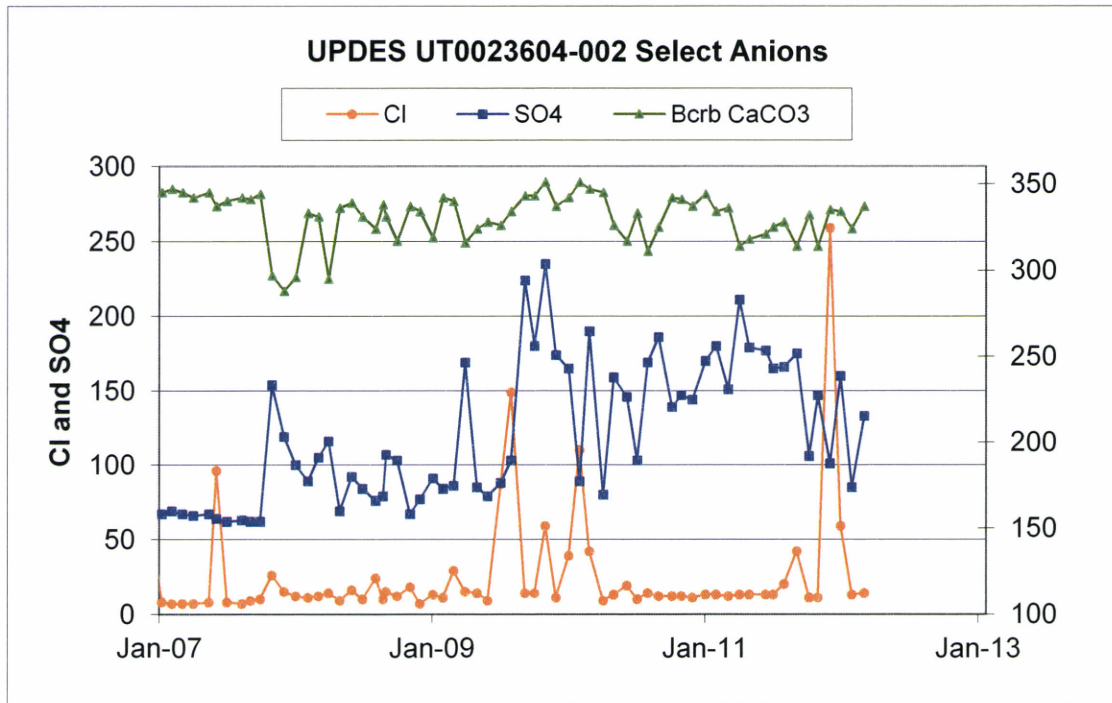
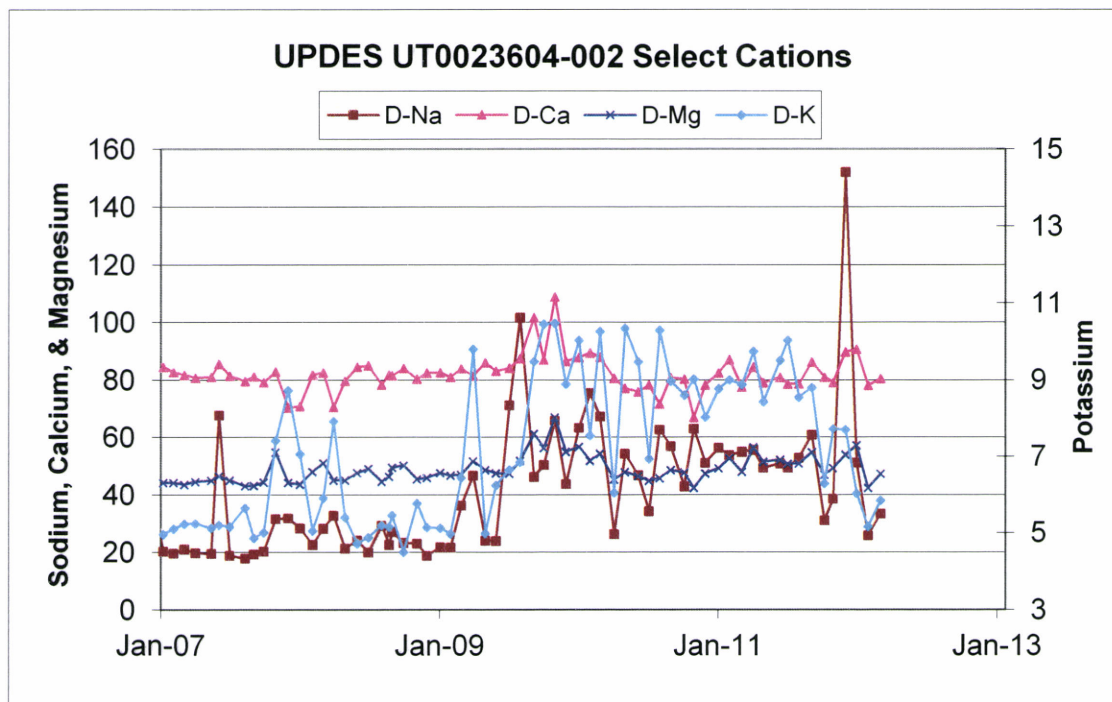
UPDES 002 March 2012 - cation-anion balance

Recently, potassium values have frequently been outside two standard deviations from the mean at UT0023604-002, but – as can be seen on the following charts – with the exception of bicarbonate, major ion concentrations have tended to fluctuated upwards in recent years. In addition, spikes in chloride and dissolved sodium and a dip in dissolved potassium have occurred over the past two quarters.

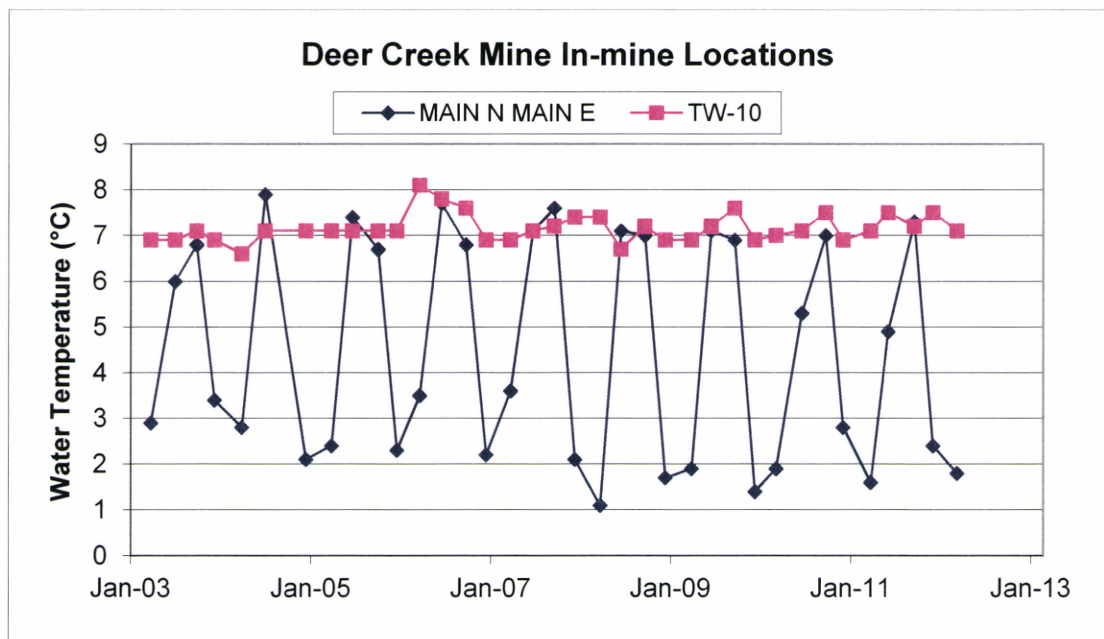
The water temperature at Main North Main East varies seasonally year-after-year (see following chart), indicating that this in-mine source is most likely fed by infiltration of surface water rather than draining surrounding strata. The temperature at TW-10 shows some seasonal variation but it is not as definitive as at Main North Main East.

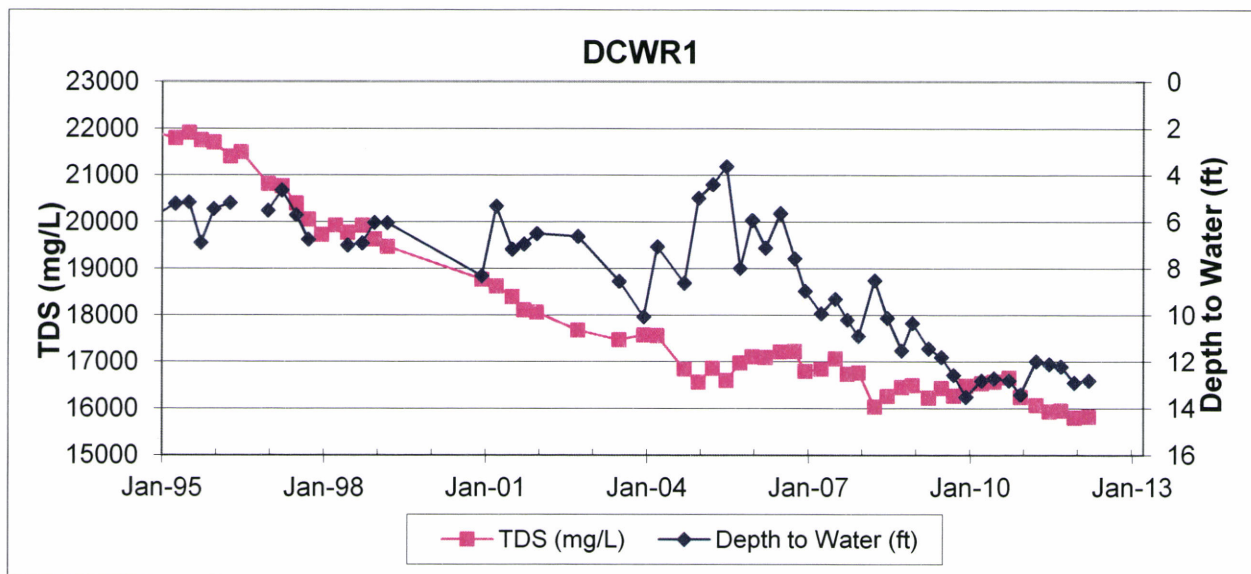
Although it hasn't been flagged as varying from the mean by more than two standard deviations, water level at DCWR1 has been dropping since 2006 (following a small rise in 2004-2005). TDS was dropping at a similar rate, but now appears to have stabilized. These changes are probably from factors other than disposal of waste rock at this site: a similar drop in water level is seen at WCWR1 at the Cottonwood/Wilberg Mine Waste Rock Disposal Site.

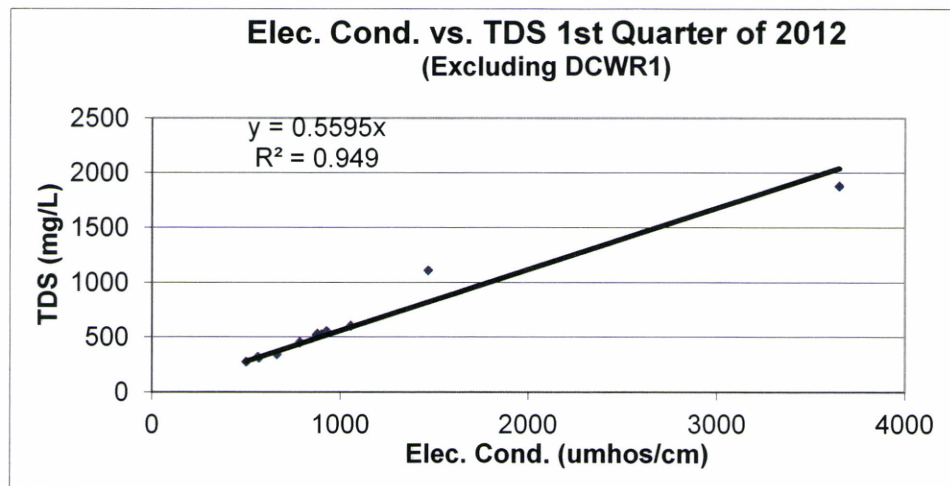
#### TDS/field electric conductivity ratios – all sites

The TDS/field electric conductivity ratio typically falls between 0.52 and 0.76 for dissolved solids concentrations found in natural waters. As the following chart shows, data for these two parameters submitted for the First Quarter 2012 at the Deer Creek Mine generally result in a ratio that falls within this range: DCWR1 is not included in the trendline calculation.
